Case study 7. Mill Brook – Tattenhall, Cheshire

Project stage: Constructed February 2016

This case study relates to project SC150005 'Working with Natural Flood Management: Evidence Directory'. It was commissioned by Defra and the Environment Agency's [Joint Flood and Coastal Erosion Risk Management Research and Development Programme](#).

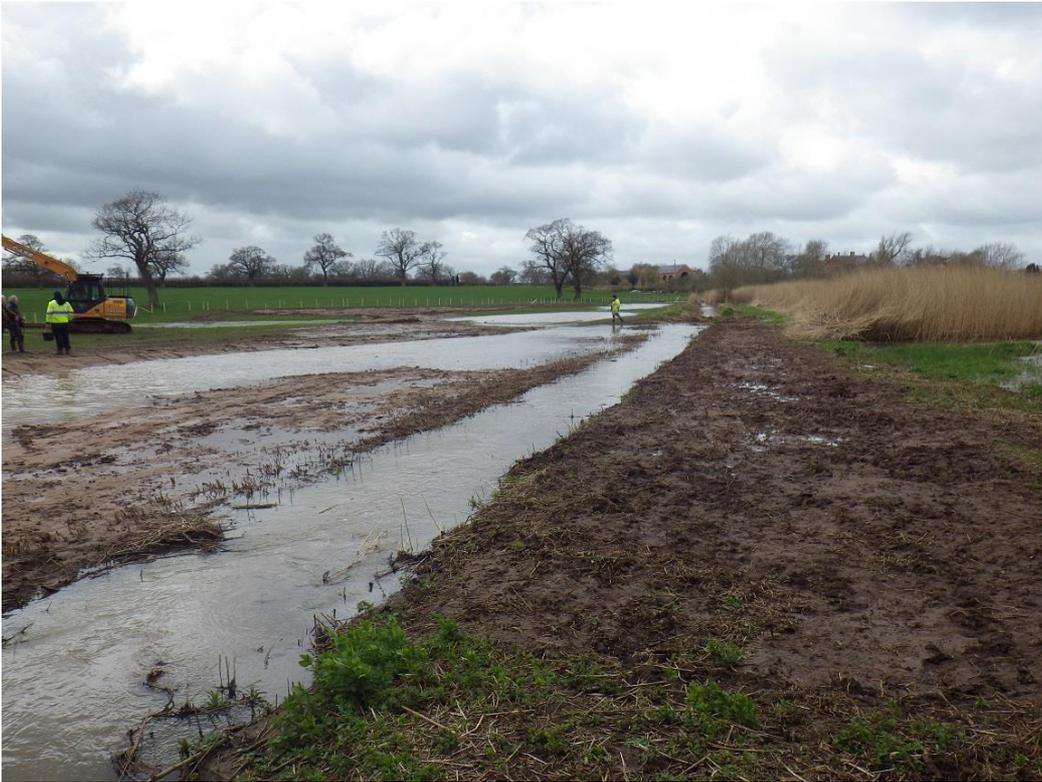
Photo 1: Mill Brook scheme following construction (source: Environment Agency)

This was a habitat creation scheme (Photo 1) which incorporated innovative, Natural Flood Management (NFM) techniques along 230m of Mill Brook, upstream of Tattenhall near Chester (Map 1). This partnership project with the Bolesworth Estate and Tattenhall Wildlife Group created 1.5ha of priority reedbed and wet grassland habitats within a new excavated floodplain area. The project helps attenuate flood peaks and reduces risk downstream in Tattenhall. The North West Regional Flood and Coastal Committee allocated £13,500 of funding to this scheme from the North West 'Slowing the Flow' project.

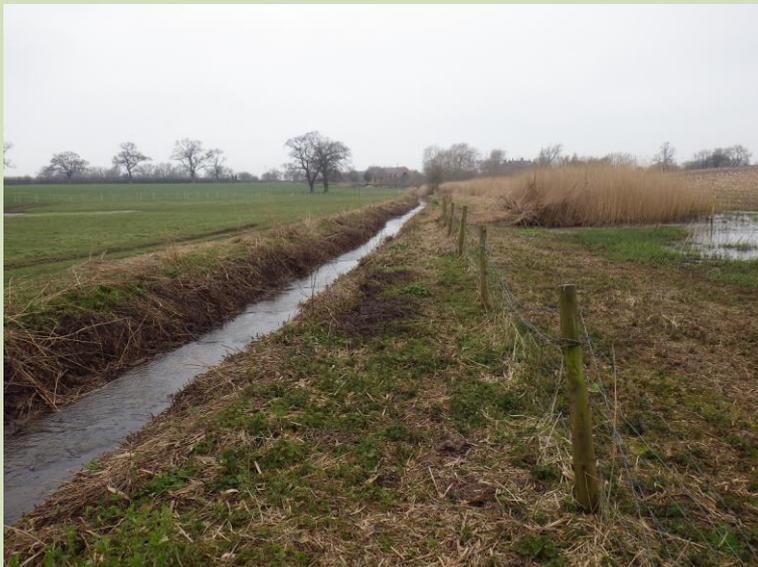
Photo 2: The site pre-construction (source: Environment Agency)

Photos 2, 3 and 4 show the site before, during and after construction.

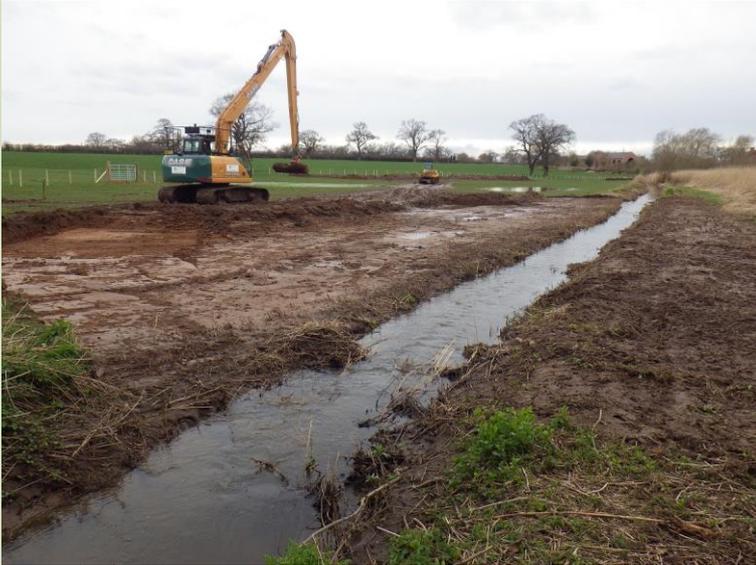
Photo 3: The site during construction (source: Environment Agency)

The embankments and floodplain were lowered using a 13-tonne excavator and the spoil was deposited 50m to the south. The woody material dams were constructed using fallen trees and branches from nearby woodland. The works were undertaken by the Environment Agency's Operations Field Team. The Tattenhall Wildlife Group installed the second dam.

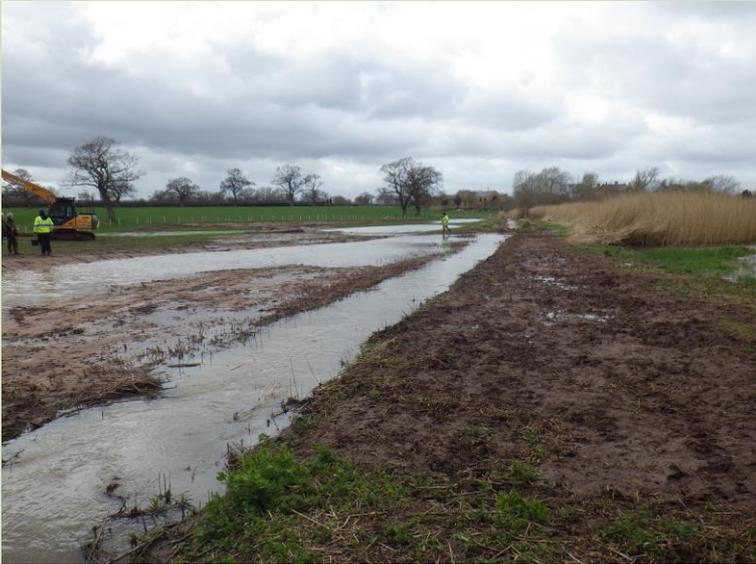
Photo 4: The site following construction (source: Environment Agency)
